## Hazardous Waste Division

### Trip Report

<b>Project</b>	Former Cedar Chemical Facility
<b>Location</b>	West Helena, AR
<b>Date</b>	06/27/2012
<b>Time</b>	day trip
<b>Reason</b>	Observe Site Conditions
<b>ADEQ personnel</b>	Clay McDaniel, Jim Rigg, Mark Lawler
<b>Facility personnel</b>	Gary Hill – Harcross employee Stanley Herrington – Harcross Site Manager
<b>Activity Summary</b>	Took tour of the facility to observe compliance
<b>Action Items Summary</b>	<ul style="list-style-type: none"> <li>• We toured the admin building to observe the status of the documents. There are estimated to be 680 boxes of documents and they are in good condition. Sagging ceiling tiles were observed (see photo #1) but the apparent leak has not yet impacted the documents.</li> <li>• An unidentified monitoring well did not have a lock on it (see photo #2).</li> <li>• The soil pile from excavation of the sump is still located on the former Unit 4 foundation (see photo #3). It has been 119 days between when it was 1<sup>st</sup> discovered and this site visit. Stan said a sample from the soil pile was taken for analysis to ETC in Memphis. It was then supposed to be taken to clean harbors, but is still i

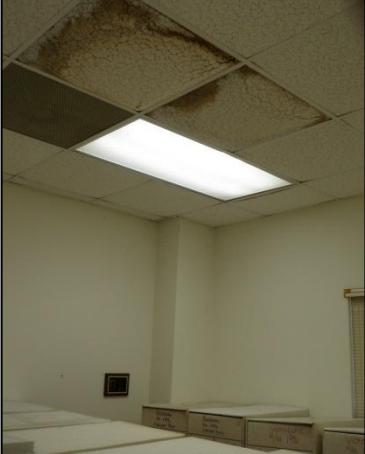
Ceiling In Admin Building	
<b>Photo # 1</b>	<b>Photographer:</b> Clay McDaniel, ADEQ
<b>Date:</b> Wednesday, June 27, 2012	<b>Witness:</b> Mark Lawler, ADEQ

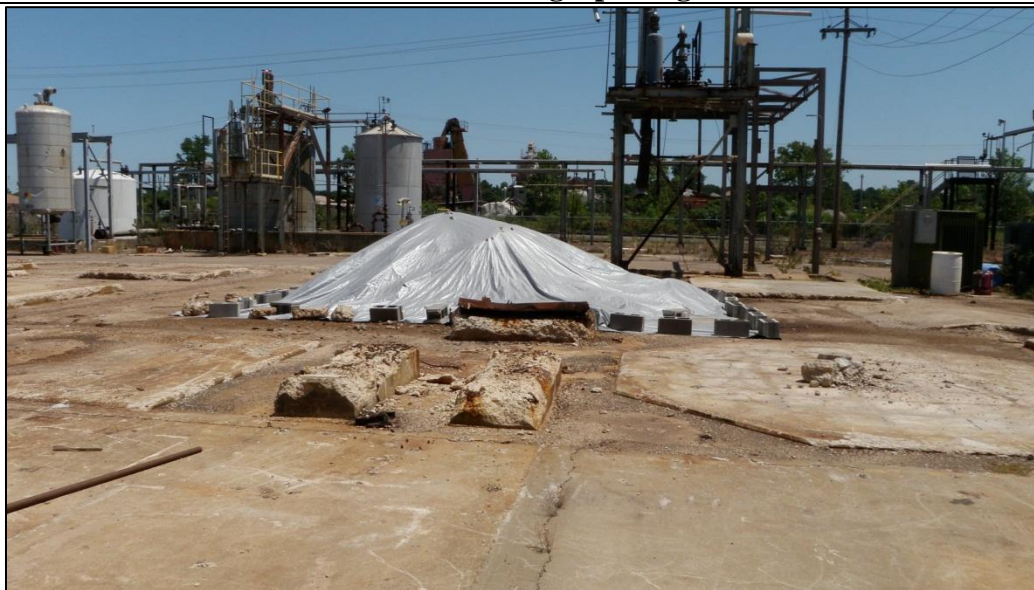
Soil Pile from Sump Excavation (located on the former Unit 4 footprint)	
<b>Photo # 3</b>	<b>Photographer:</b> Clay McDaniel, ADEQ
<b>Date:</b> Wednesday, June 27, 2012	<b>Witness:</b> Mark Lawler, ADEQ

<b>Anticipated follow-up</b>	Harcross has not provided ADEQ with bi-weekly updates on the status of the soil pile or met the 45 day deadline to respond to remove the IDW (expired on 05/18/12). A letter should be sent to Harcross to site them of their failure to follow up ADEQ's request.
<b>Other</b>

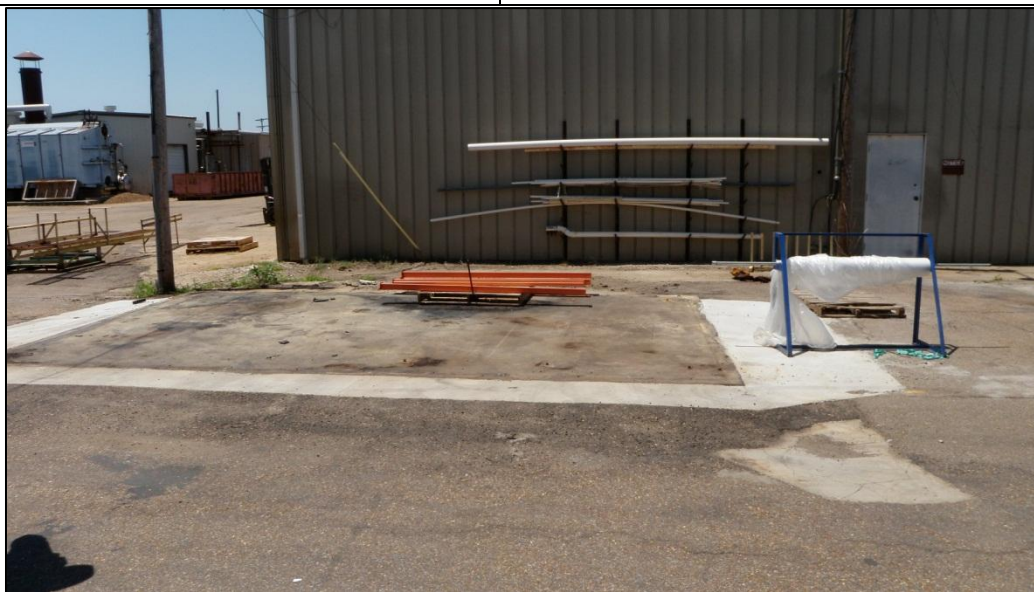
**Photo #** 4

### Newly Paved Area to Replace Cracked Asphalt
